PHASE I REPORT  
NATIONAL DAM SAFETY PROGRAM  
TENNESSEE

Name of Dam ..... Jennings Creek Watershed Dam No. 15  
County ..... Jackson  
Stream ..... Trib. of Jennings Creek at Hudson Hollow  
Date of Inspection ..... January 8, 1981

JENNINGS CREEK  
DAM NO.  
15

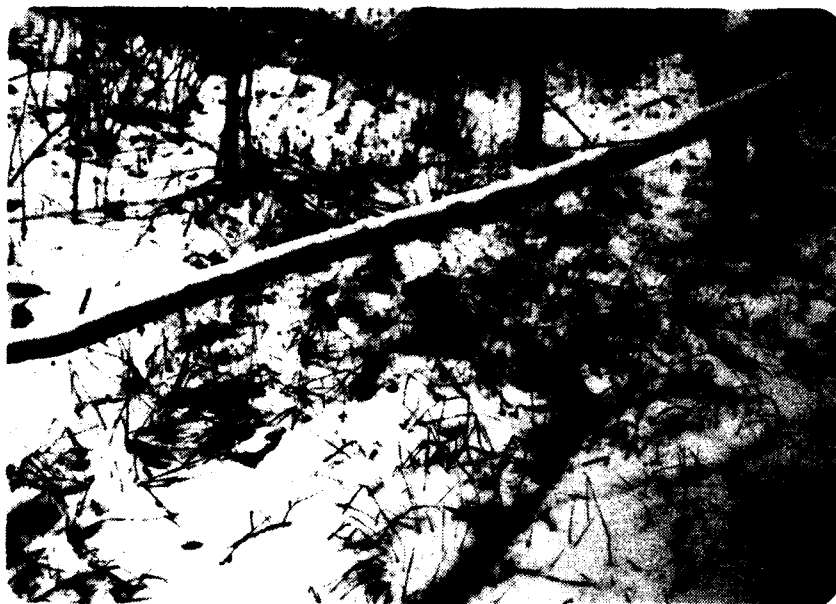
PHOTO NO. 11

- Photo No. 11 - Artesian well several feet downstream of embankment at right side.
- Photo No. 12 - Principal spillway outlet and plunge pool.
- Photo No. 13 - Monument showing plaque.
